Manhole Inspection Summary

Manhole # S67E__003MH

Insp Date: **3/23/08 9:53 AM**

Location Address: **E. Pratt Street**

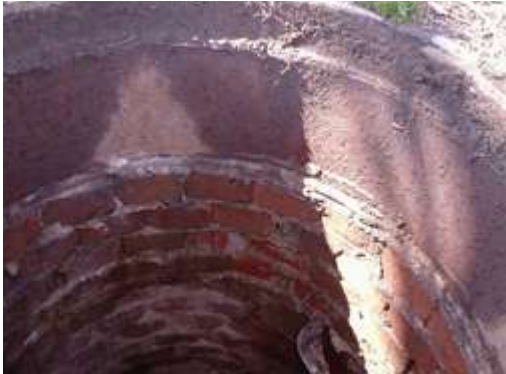
Defect 2

Frame Offset: **2** (in.) Condition: ☐ Sound ☐ Cracked ☒ **Leaks**

Frame Leaks

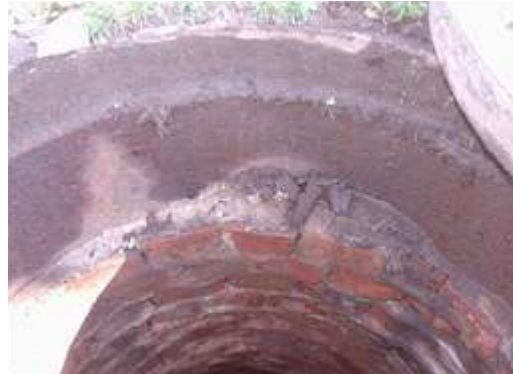
Defect 1

Condition: ☐ Sound ☐ Cracked ☐ Root Intrusion ☐ Loose Brick ☒ **Deteriorated**

Infiltration: ☐ None ☒ **Joint** ☐ Cracks ☐ Mortar ☐ Roots ☐ Wall

Adjustment Joint

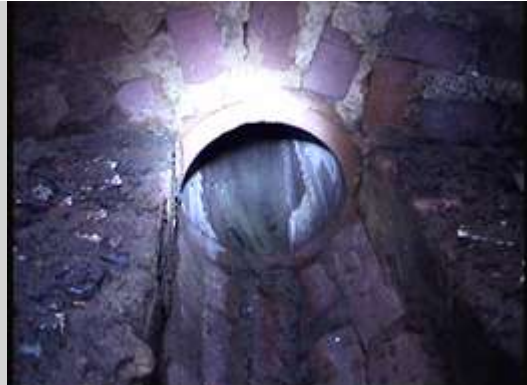
12 O'Clock Outflow

8 in. Circular Gravity Sewer
Pipe Out @ 12 O'Clock

Pipe Height: **8.4** (in.) Rod and Bar (Angled)
Pipe Material: **Clay** ☐ Pipe Lined
Invert Depth: **8.70** (ft.) Flow Characteristics: **None**
Deposits: ☒ None ☐ Mud ☐ Sludge ☐ Debris ☐ Grease
Silt Depth: (in.) Deposits Extent:
Infiltration: **None** Pipe Seal Cond: **Sound**

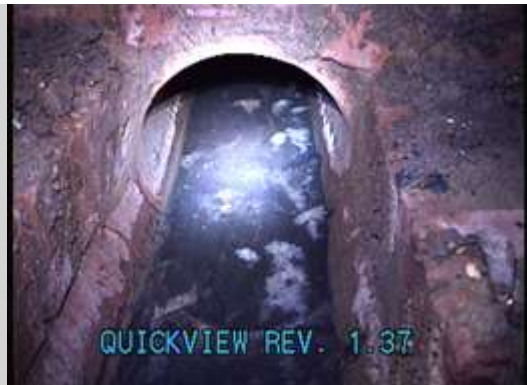
6 O'Clock Inflow

8 in. Circular Gravity Sewer
Pipe In @ 6 O'Clock

Pipe Height: **8.4** (in.) Rod and Bar (Angled)
Pipe Material: **Clay** ☐ Pipe Lined
Invert Depth: **8.65** (ft.) Flow Characteristics: **None**
Deposits: ☒ None ☐ Mud ☐ Sludge ☐ Debris ☐ Grease
Silt Depth: (in.) Deposits Extent:
Infiltration: **None** Pipe Seal Cond: **Sound**
